Environmental Analysis Associates, Inc.

Identifying the fiberglass fibers and debris produced from the shedding of HVAC black soundliner insulation

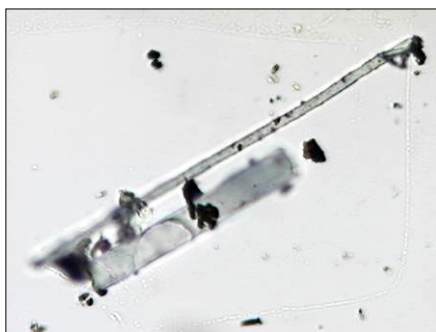
Example of fiberglass fibers associated with black soundliner insulation (Photo #1). Photo #2 shows intact black binder resin

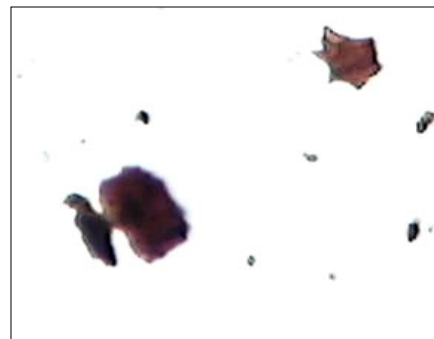
Resin binder dust

Examples of black and rust colored resin binder particles using optical microscopy (~1000x). Particles appear black with an irregular or plate-like morphology.

When the particles are thick, they appear black (opaque) and brown or rust colored when they are thin and plate-like.

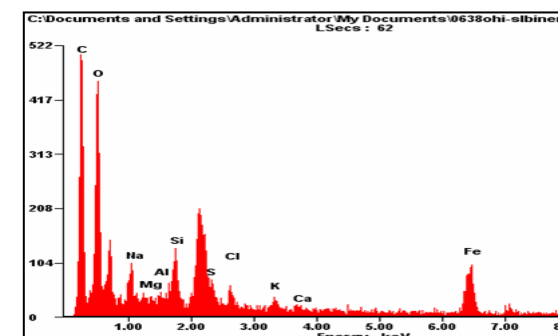
SEM photo 2890x

Particle binder agglomerate mixed with moderate concentrations of iron.
